CASE STUDY MS0364

REMOVAL AND REPLACEMENT OF STAINLESS STEEL TANKS

Cardowan

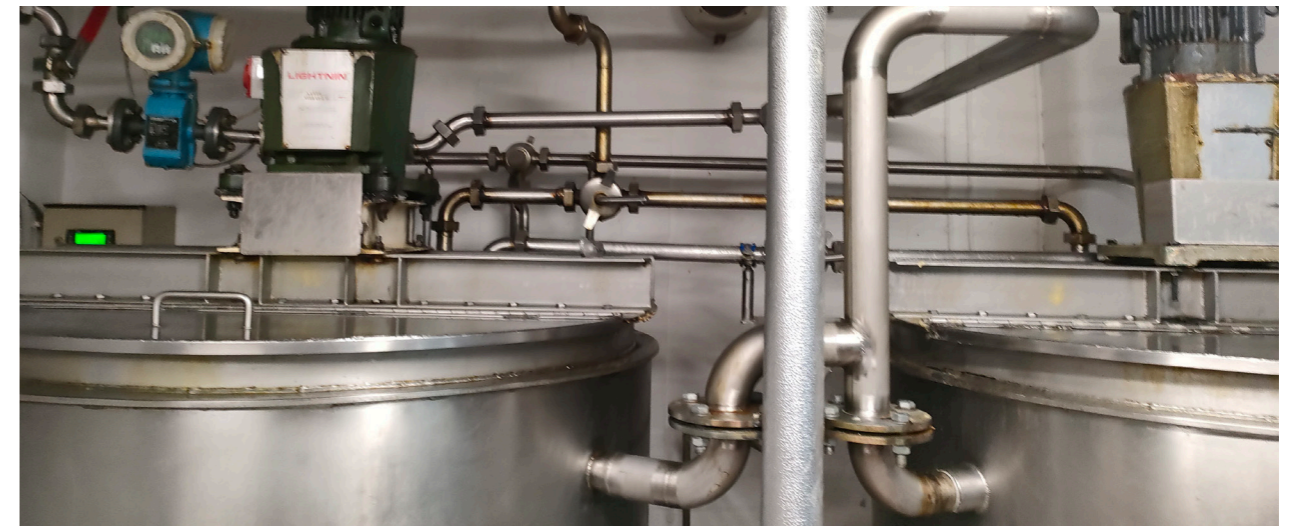
Figure 2: New tanks in position with new lids and new pipework connected to old

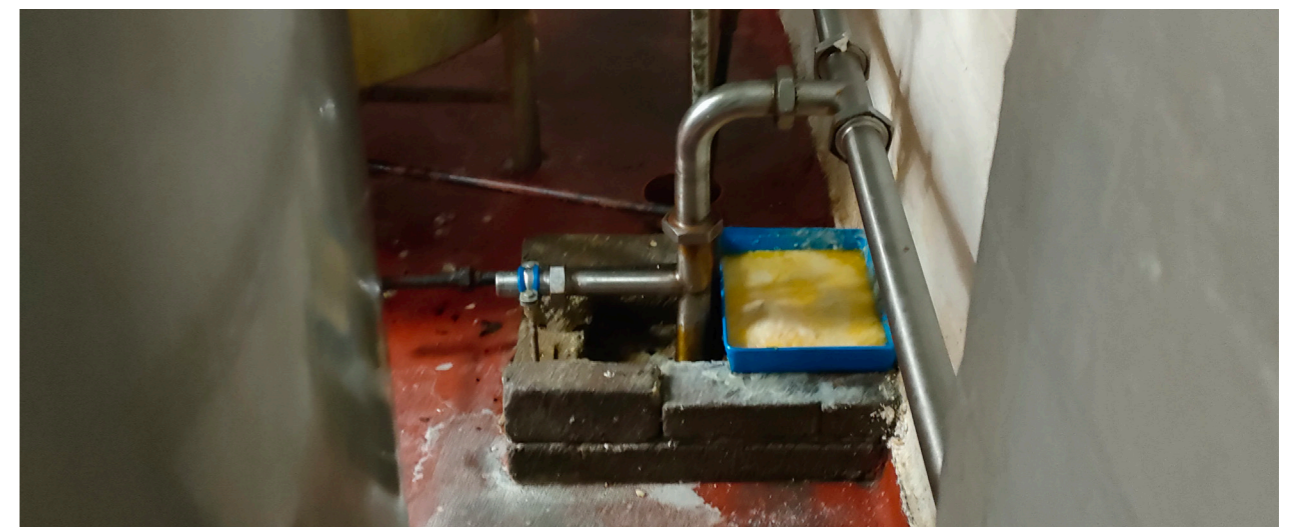
Figure 3: New pipes exiting tanks connected to product flow

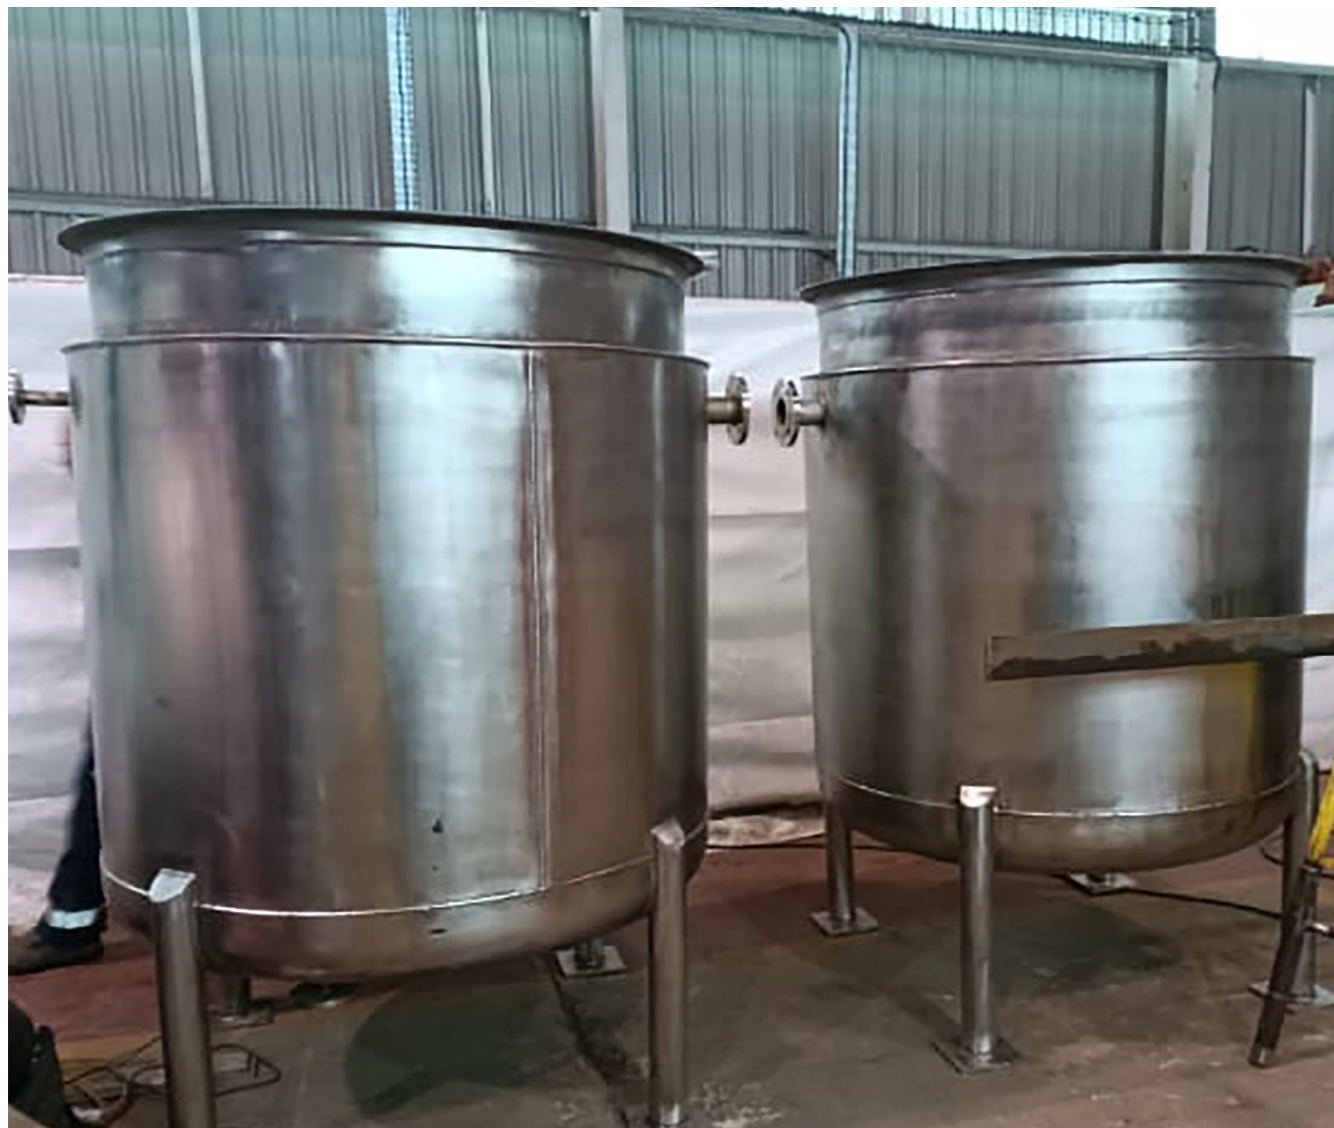
Figure 4: New tanks and associated lids pre connections and pipework

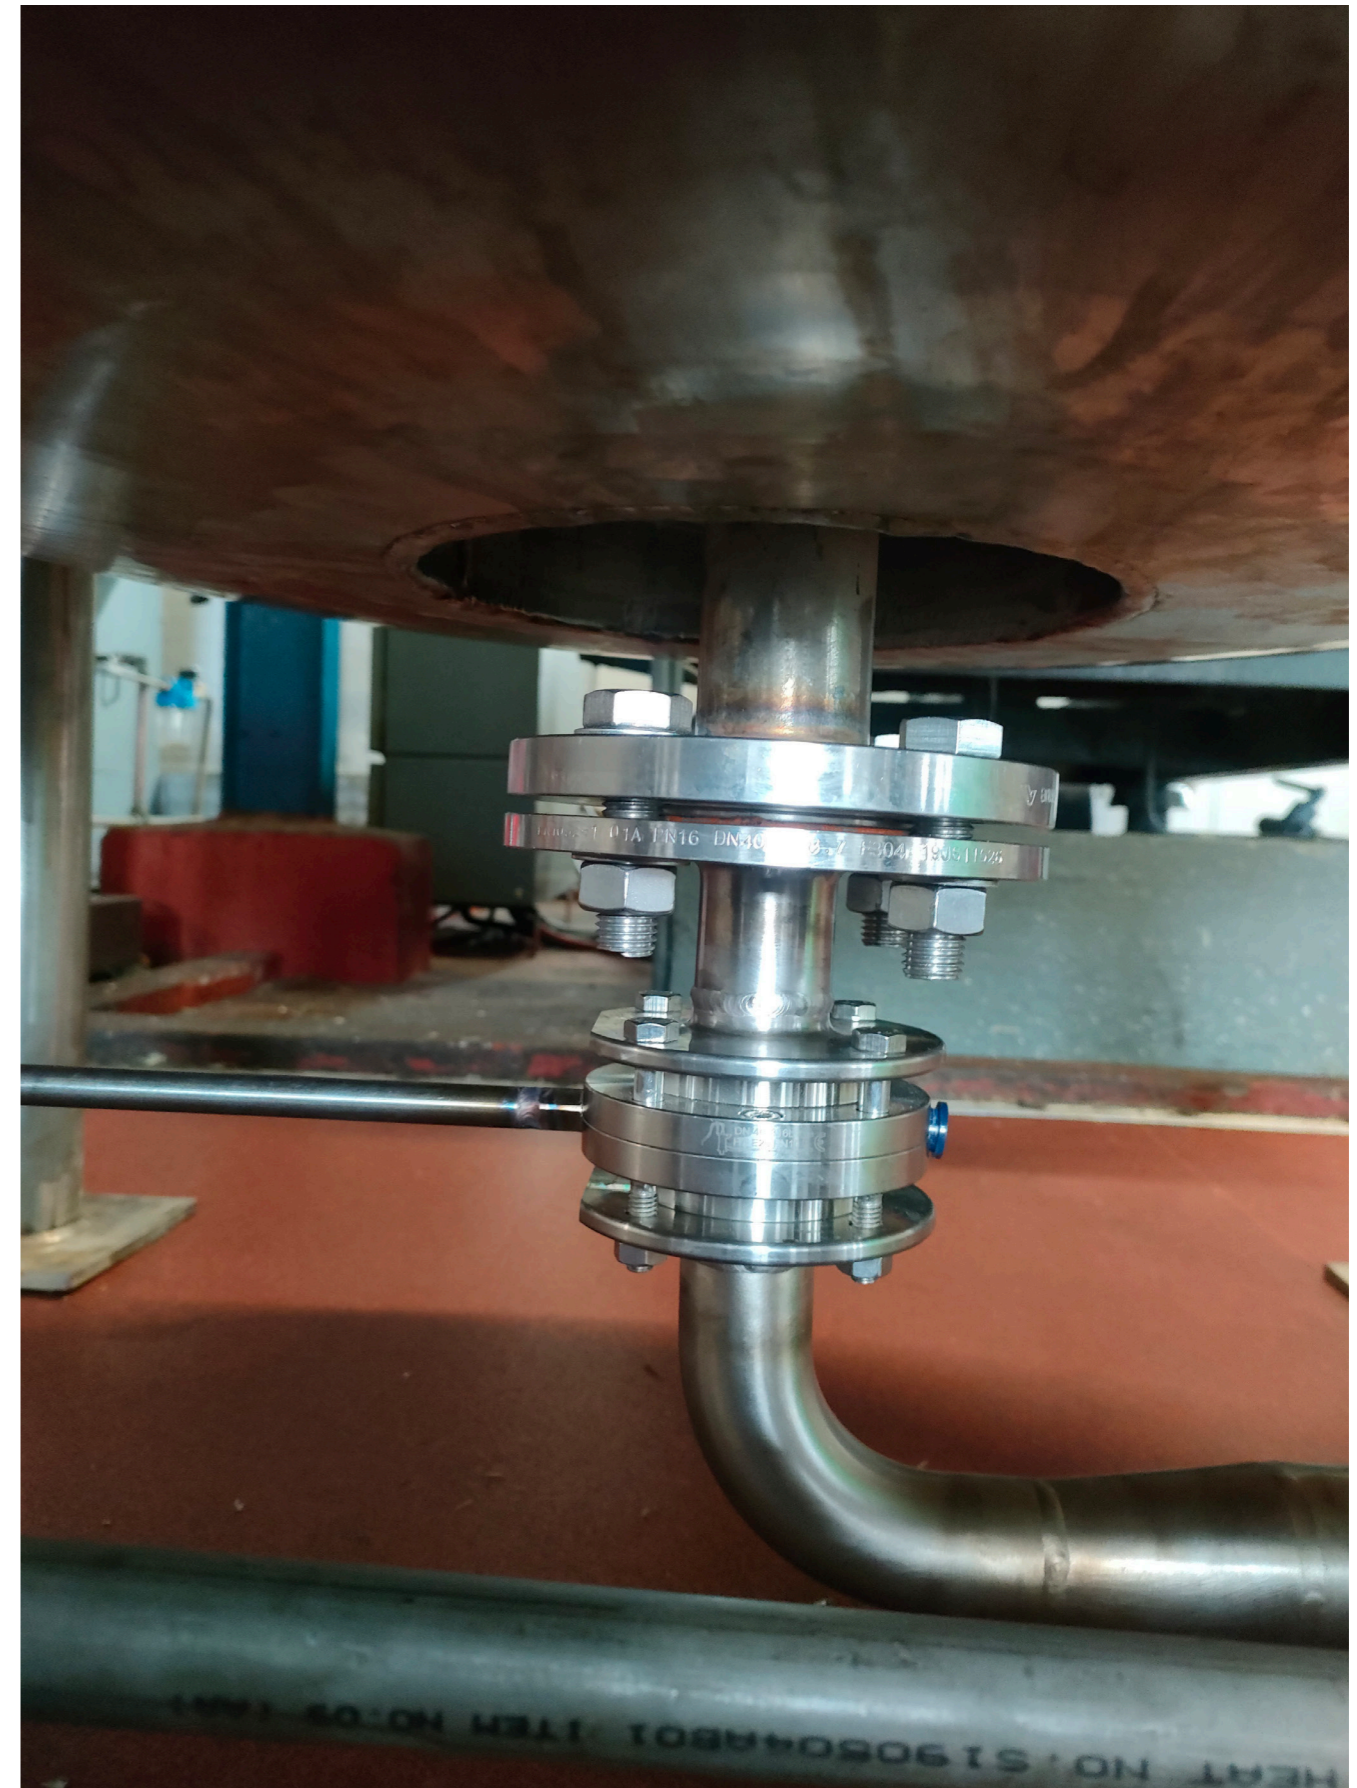
Figure 5: New connections and joints to allow steam and food product to travel without obstruction
